Manhole Inspection Summary

Manhole # S33KK1001MH

Insp Date: **4/28/07 9:35 AM**

Location Address: **4214 GREENWAY**

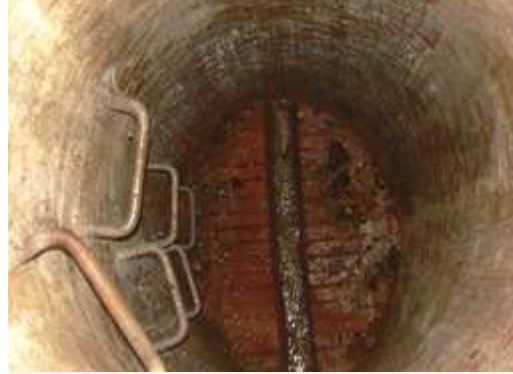
Top View

Bench debris.

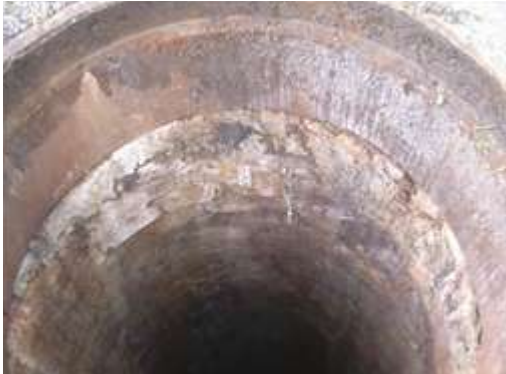
Defect

Frame leaks. Adjustment deterioration and infiltration. Corbel and Barrel infiltration.

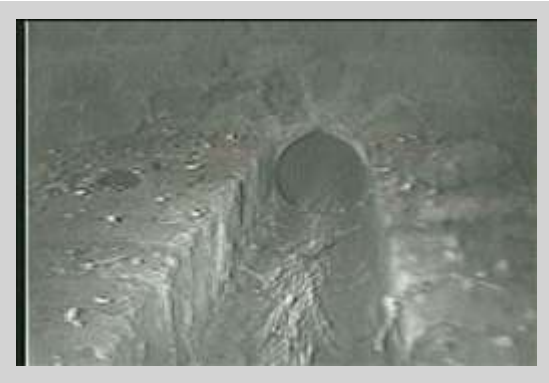
6 in. Circular Gravity Sewer Pipe Out @ 12 O'Clock

Infiltration: **Evidence** Pipe Seal Cond: **Broken**

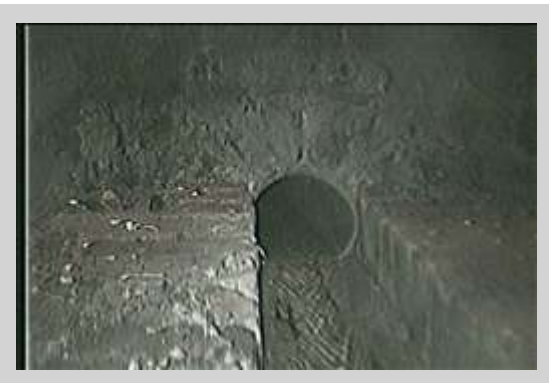
6 in. Circular Gravity Sewer Pipe In @ 6 O'Clock

Infiltration: **Evidence** Pipe Seal Cond: **Unknown**
